# D-Cracking Rehabilitation at **Kansas City International**

## **2015 Airports Conference**

## **Introduction**

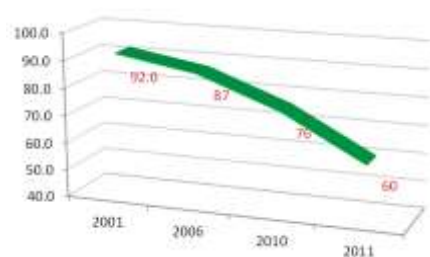
Historical  
PCI of RW 1L-19R

- Dropped 32 points in 10 years and 27 points in 5 years

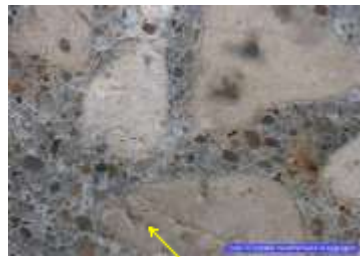
Photos Courtesy WJE Associates – Kansas City International Airport – Petrographic Studies of Twelve Concrete Cores – May 23, 2011

- Petrographic Analysis
- Strategic Core Locations – Mid Slab and On Distress
- Confirmed D-Cracking as Distress, Not ASR
- Freeze-Thaw Induced Microfractures
- Marginal to Poor Air Content
- Large Variation in Aggregate Size

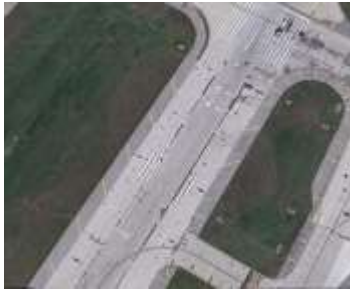
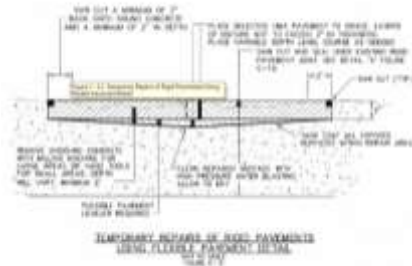
- **Temporary Solution:**
  - Fast Tracked to Repair Each Transverse Joint, Location of Primary Manifestation
  - Use FAA Standard Detail for Mill / Remove / Replace on AC Joints
  - DTW Example

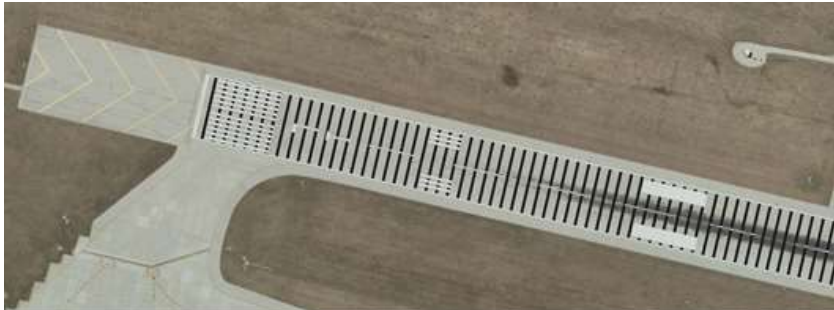
- 2 new cut lines at each joint (Cuts from 2010 Repairs Deteriorating)
- Longitudinal Joints not addressed
- Internal Slab Pop-outs and Spalls not addressed
- Smoothness
- Look of the Runway

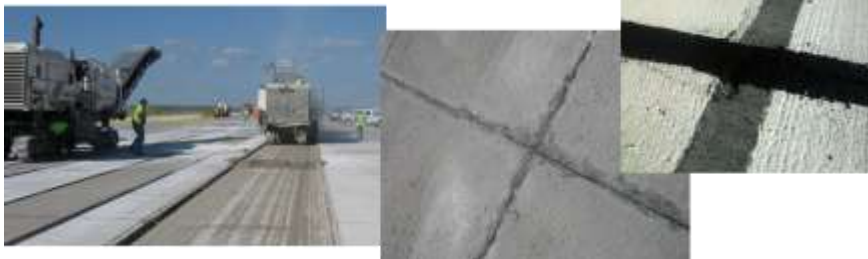
- Final Selected Solution:
  - Mill 4” of PCC / Replace with 4” of AC
  - Depth of D-Cracking (4”) – Cores and Petrographic Analysis
  - Structural Verification Indicated Adequate Section (Super Base)
  - No NAVAID adjustments – No In-Pavement Lighting Adjustments
  - No Surrounding Pavement Adjustments
  - Preliminary Estimate at Approx. \$20 Million

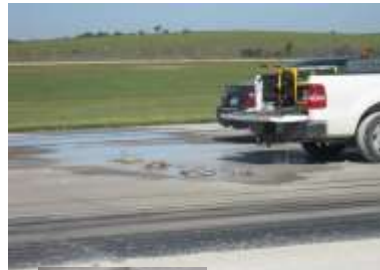
- Construction Challenges
  - In-Pavement Lighting
  - Variable Depth D-Cracking
  - Reinforcing Steel Depth
  - Very Late in the Year for the Midwest Construction Season

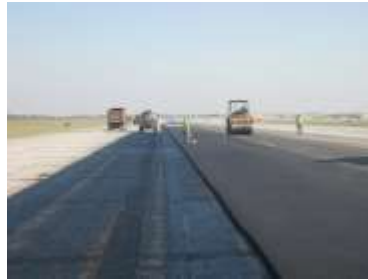
- **Final Product**
  - Extremely smooth pavement
  - National Asphalt Pavement Association (NAPA) Quality in Construction Award

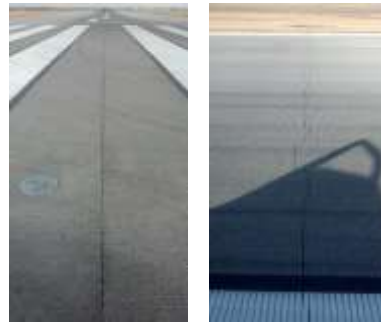
- **Reflective Cracking**
- **Longitudinal Seam**
- **Expansion Joints**
- **Hi-Speed Exits**
- **Crack-Seal Program**
